ANNUAL REPORT FOR 2004

Big Warrior and Little Warrior Creek Mitigation Site
Wilkes County
WBS Element 34404.4.1
TIP No. R-2239 B

Prepared By:
Office of Natural Environment & Roadside Environmental Unit
North Carolina Department of Transportation
January 2005

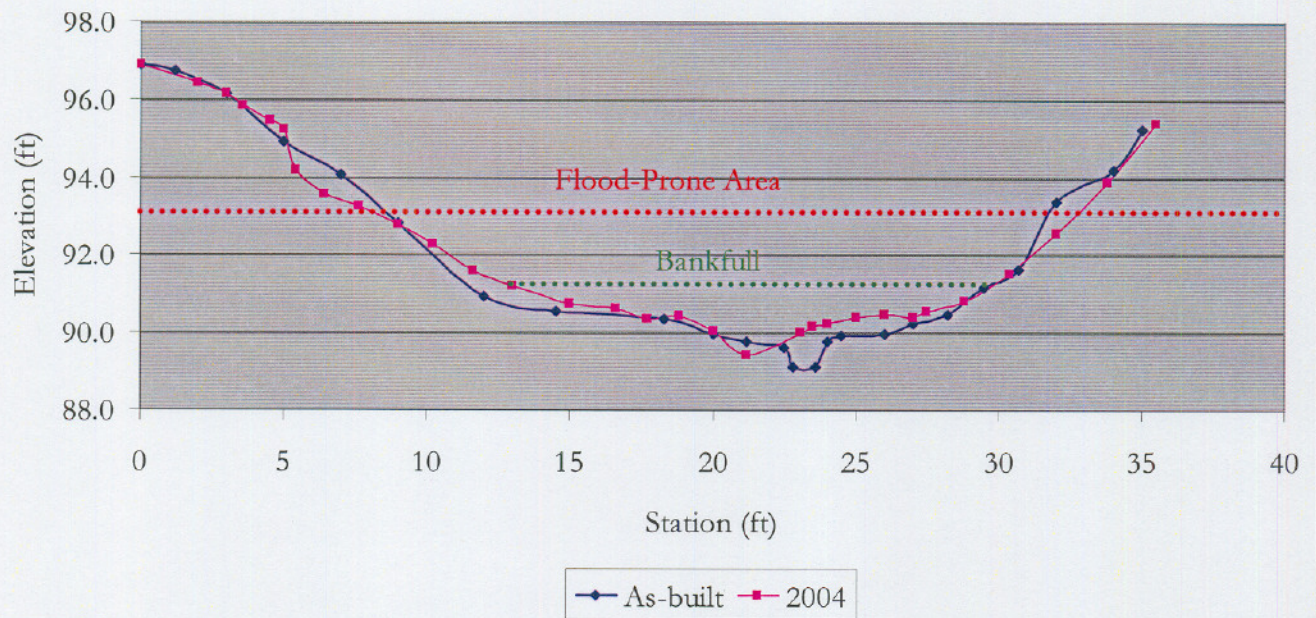
Cross Section #13 Little Warrior Creek

Cross-Section #13 (Riffle) Abbreviated Morphological Summary

As-built	2004
Bankfull Cross Sectional Area (ft ²)	3.6	13.1
Maximum Bankfull Depth (ft)	1.1	1.8
Bankfull Mean Depth (ft)	0.4	0.8
Width/Depth Ratio	20.3	21.2
Entrenchment Ratio	2.1	1.4
Bankfull Width (ft)	8.5	16.7
Width of Flood Prone Area	18	24

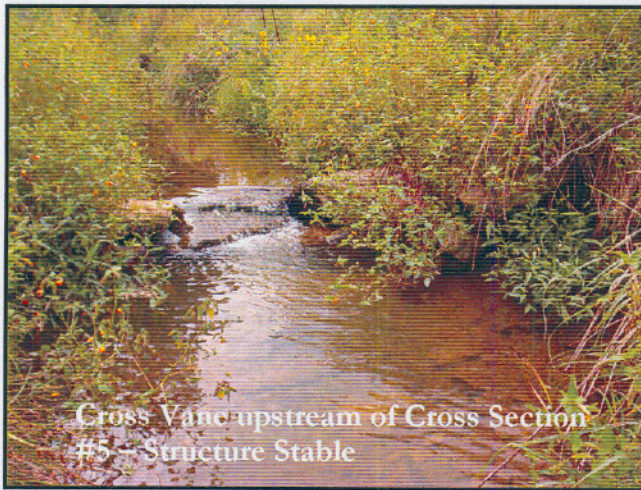
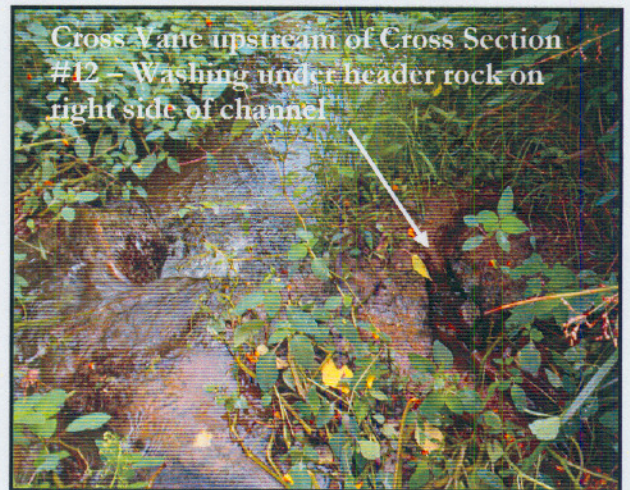
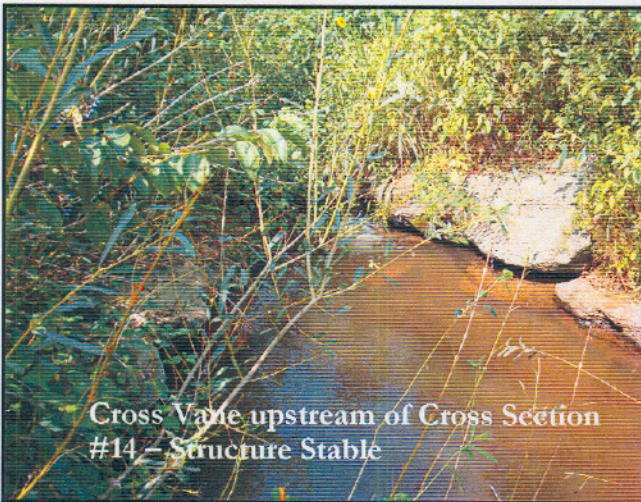
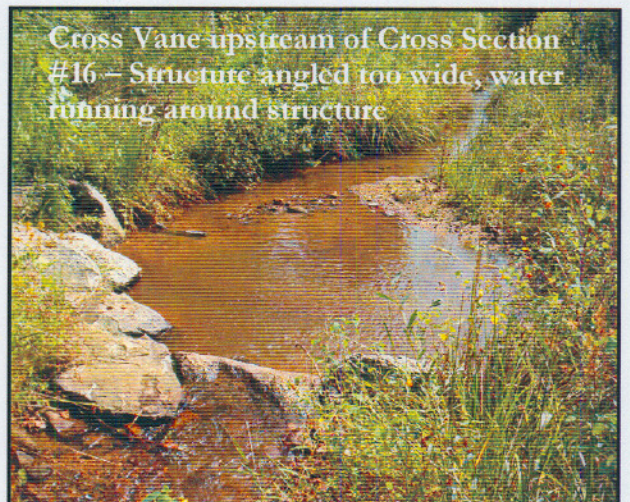
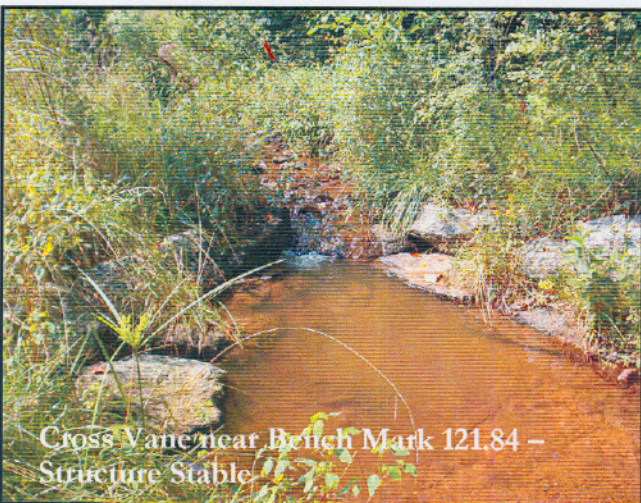
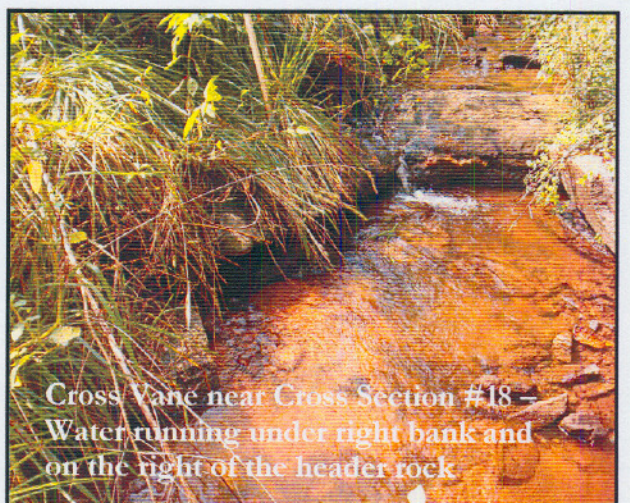
Big Warrior Creek Structures

- ◆ A large number of the structures within this segment of profile appear unstable. Water was noted either flowing around the structures or underneath the header rocks. In turn, this is causing erosion of the adjacent streambanks in several areas.

Big Warrior Creek remains stable; however, there are isolated areas of degradation and instability. A number of the structures are not functioning properly throughout the Upper Pasture and Feed Lot Sections. These areas should be assessed during the next monitoring period to determine if remedial actions are necessary.

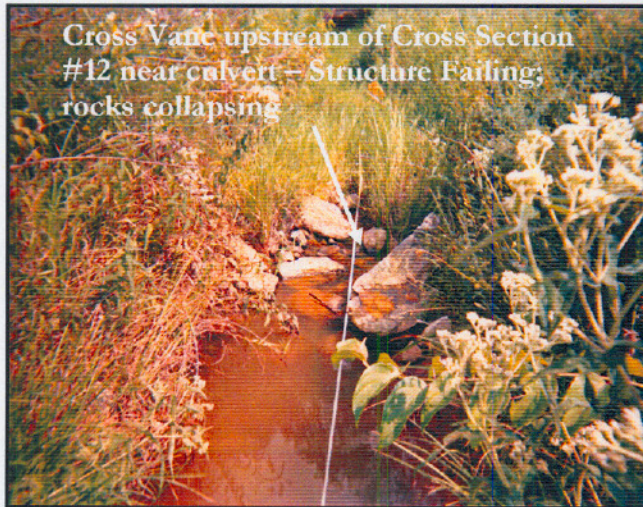
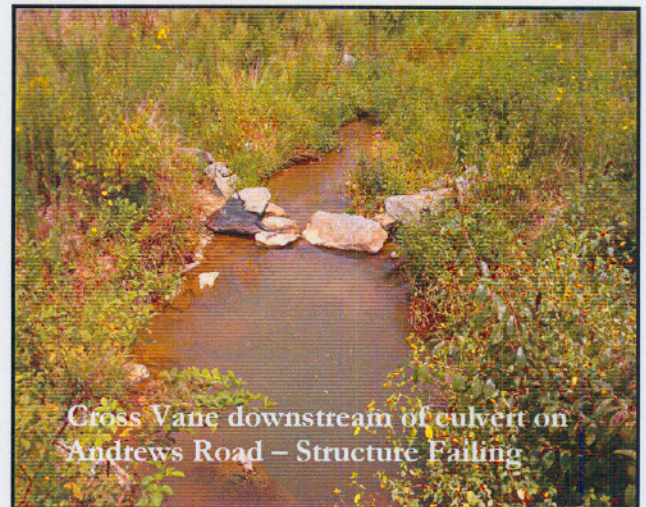
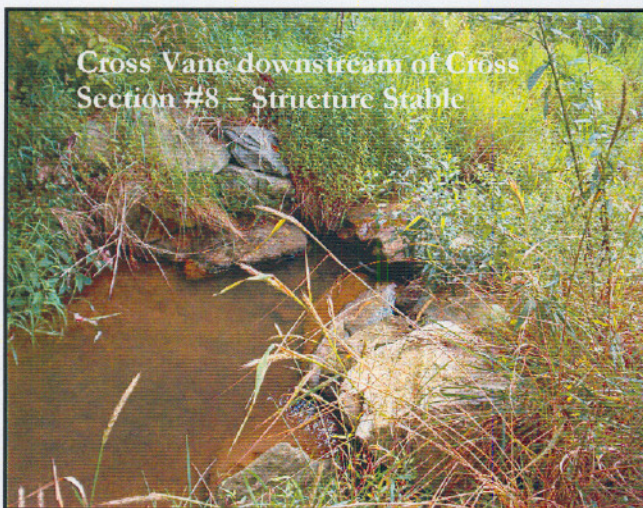
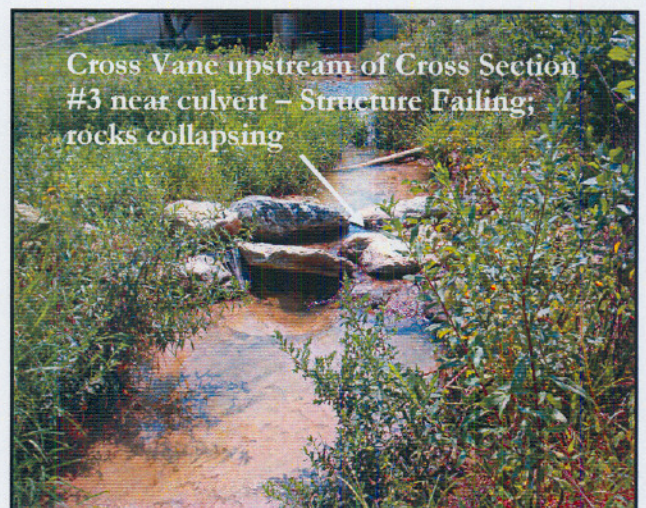
Little Warrior Creek Structures

- ◆ The structures along this segment of profile are not functioning properly. A structure near the beginning of profile has become unstable. The header rock along with other rocks that make up the structure have become dislodged and are now scattered downstream. A large scour area has formed just downstream of this structure. This scour along the left streambank extends beyond the conservation easement. Other structures in this segment were noted as having water flowing around them or underneath the header rocks.

- ◆ The structures in this segment of profile are also not functioning properly. The structure immediately downstream of the culvert under Andrew's Road has lost several of its rocks, including the header rock. Other structures in this segment were also noted as having water flowing around them or underneath the header rocks.
